# 道路案内標識の着氷雪対策に関する研究

Measures for Controlling Snow and Ice Accretion on Road Signs

## 道路案内標識の対策工の調査

Investigation of Road Sign Designs

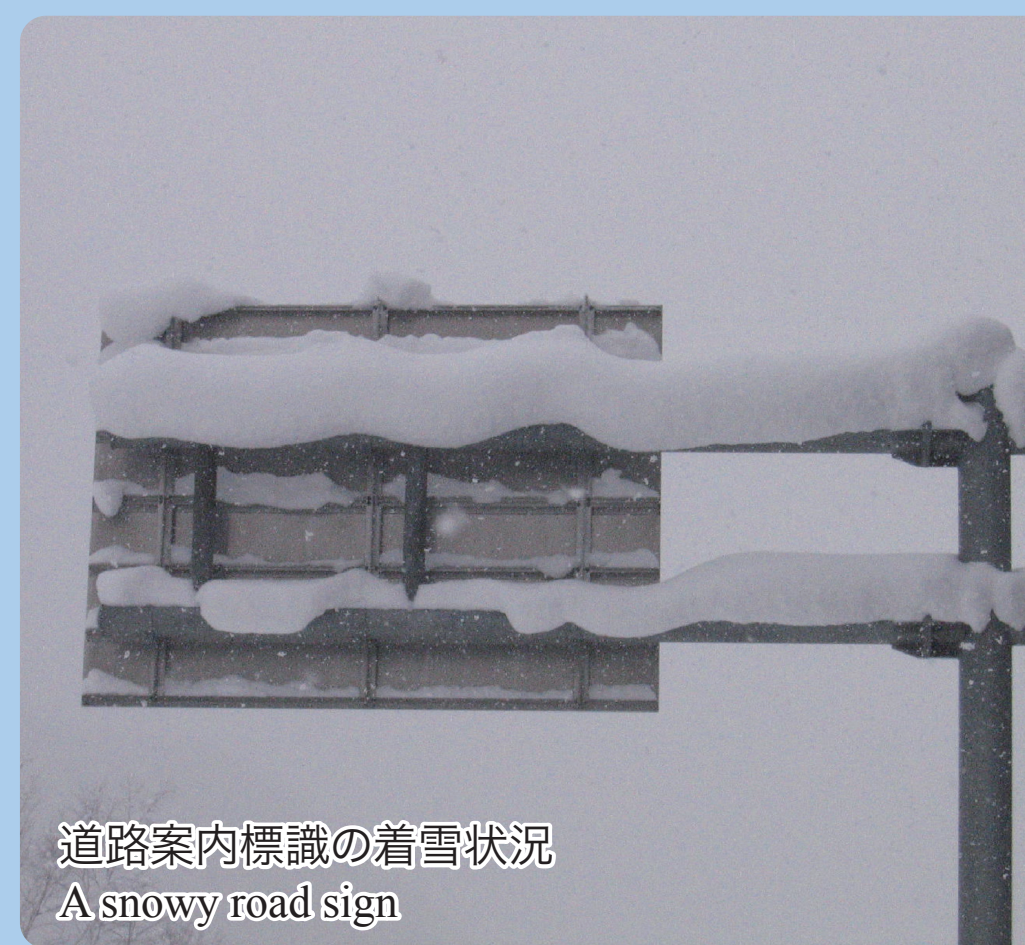
道路案内標識の着雪状況  
A snowy road sign

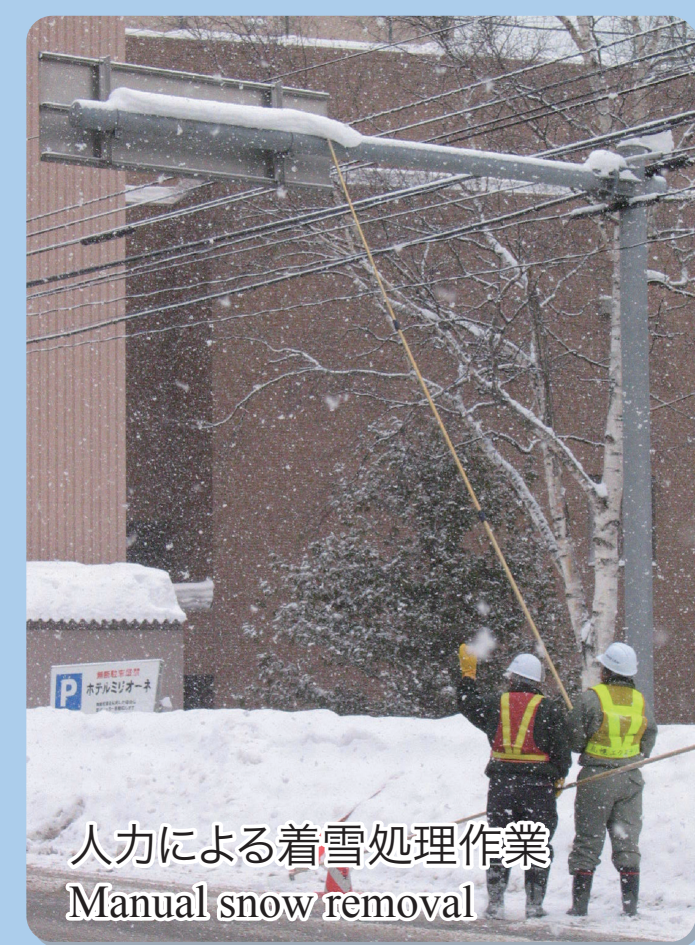
人力による着雪処理作業  
Manual snow removal

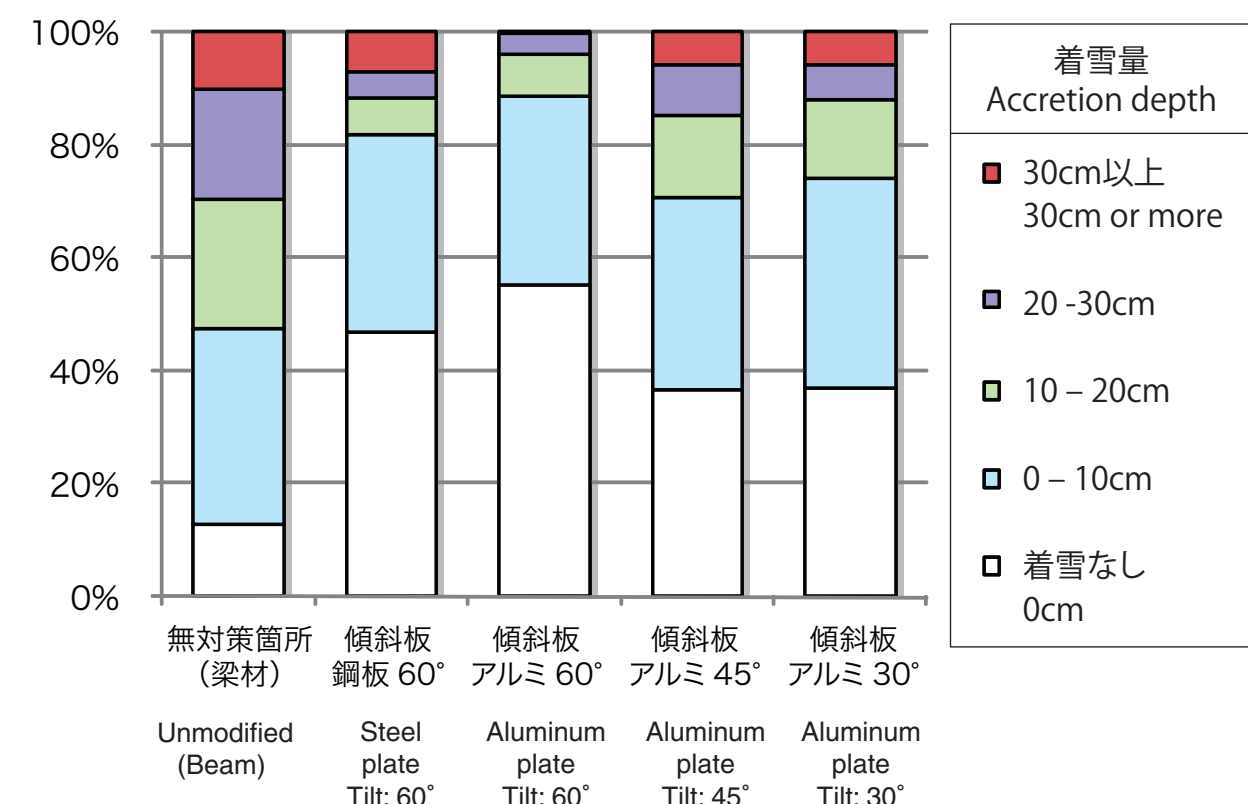
▲各着雪対策工の着雪量と観測期間中の着雪時間の割合（定山溪の例）  
Snow accretion on each specimen: Accretion depth and cumulative duration during the observation period (Jozankei Site)

観測期間 (2010/12/24～2011/3/18)  
Observation period (Dec. 24, 2010 to Mar. 18, 2011)

簡易な着雪の対策として、形状、材質および角度を変えた板（傾斜板）を、試験用の道路案内標識に設置し、着雪と落雪状況の調査を行っています。対策を行った箇所では、対策を行っていない箇所より、観測期間中において着雪している時間が25～42%短くなりました。また、勾配60°の傾斜板が最も着雪している時間が短く、鋼製よりもアルミ製の方が着雪量を減らす傾向が見られました。勾配が30°と45°では、効果にあまり違いは見られませんでした。

We have been conducting field experiments toward developing a simple and efficient way to control snow accretion on road signs by equipping the signs with protective plates. The plates differ in materials, shapes and installation angles. Our observations have shown that road signs equipped with the test plates show accretion for 25% to 42% less time than for conventional road signs. The least time with snow accretion was for signs with plates tilted at 60°. Aluminum plates were found to be more effective than steel ones at reducing snow accretion. The plates tilted at 30° and those tilted at 45° did not differ in their effectiveness in reducing snow accretion.
