# 吹きだまり対策に関する研究

## Snowdrift Countermeasures

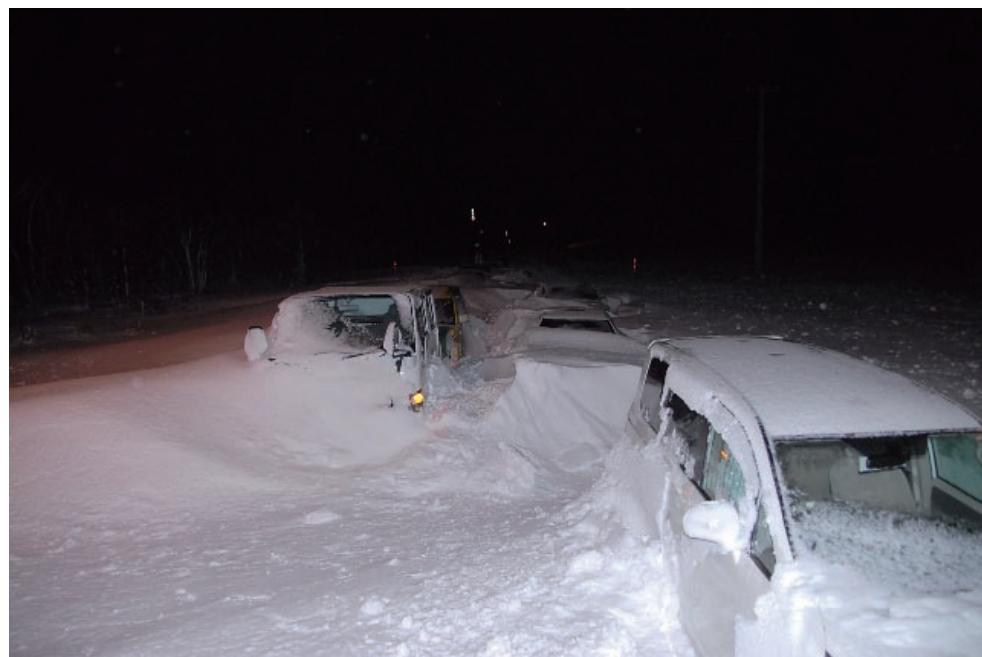
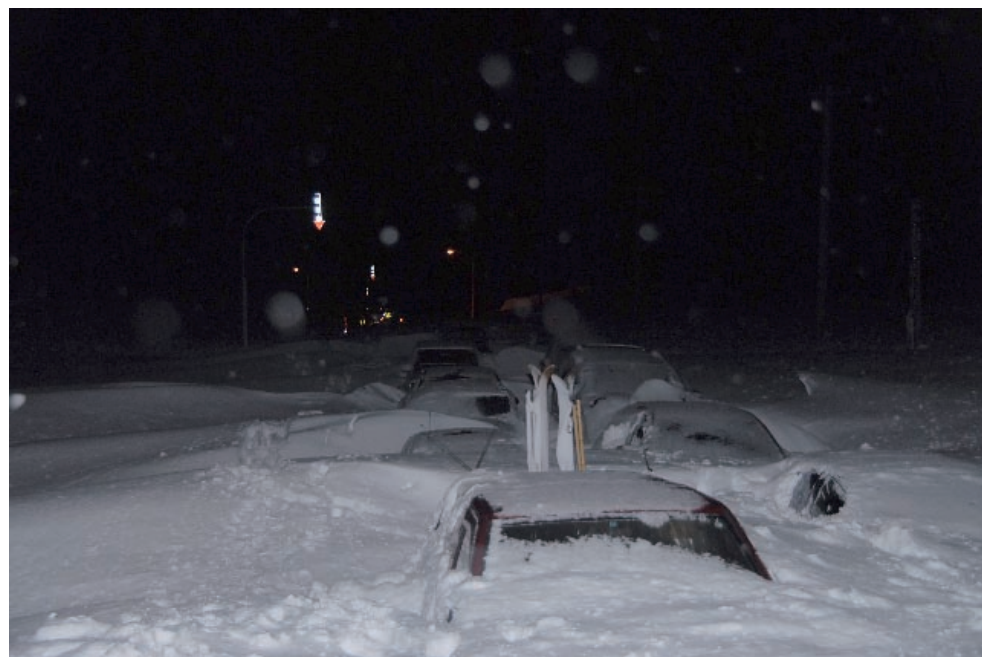
▲吹きだまりによる車両の立ち往生 国道 336 号えりも町 (H22.1.5-6) (室蘭開発建設部提供)

Vehicles trapped in snowdrifts

National Highway 336 in Erimo Town (January 5 - 6, 2010)

北海道では、2008年2月と4月に大規模な吹雪により通行止めが多発し、2月の例では豊浦町で雪に埋もれた車両で1名の死者を出す惨事となりました。また、2010年1月にはえりも町で車両50台が、2月には新潟市で車両100台が吹きだまりにより立ち往生しており、吹きだまり災害の防止が喫緊の課題となっております。

A lot of traffic closures occurred in February and April 2008, and one driver died in a trapped car in Toyoura Town during the February snowstorm. Fifty cars were trapped in snowdrifts in Erimo Town in January 2010, and 100 cars were trapped in snowdrifts in Niigata City in February 2010. The prevention of disasters caused by snowdrifts is an urgent problem.

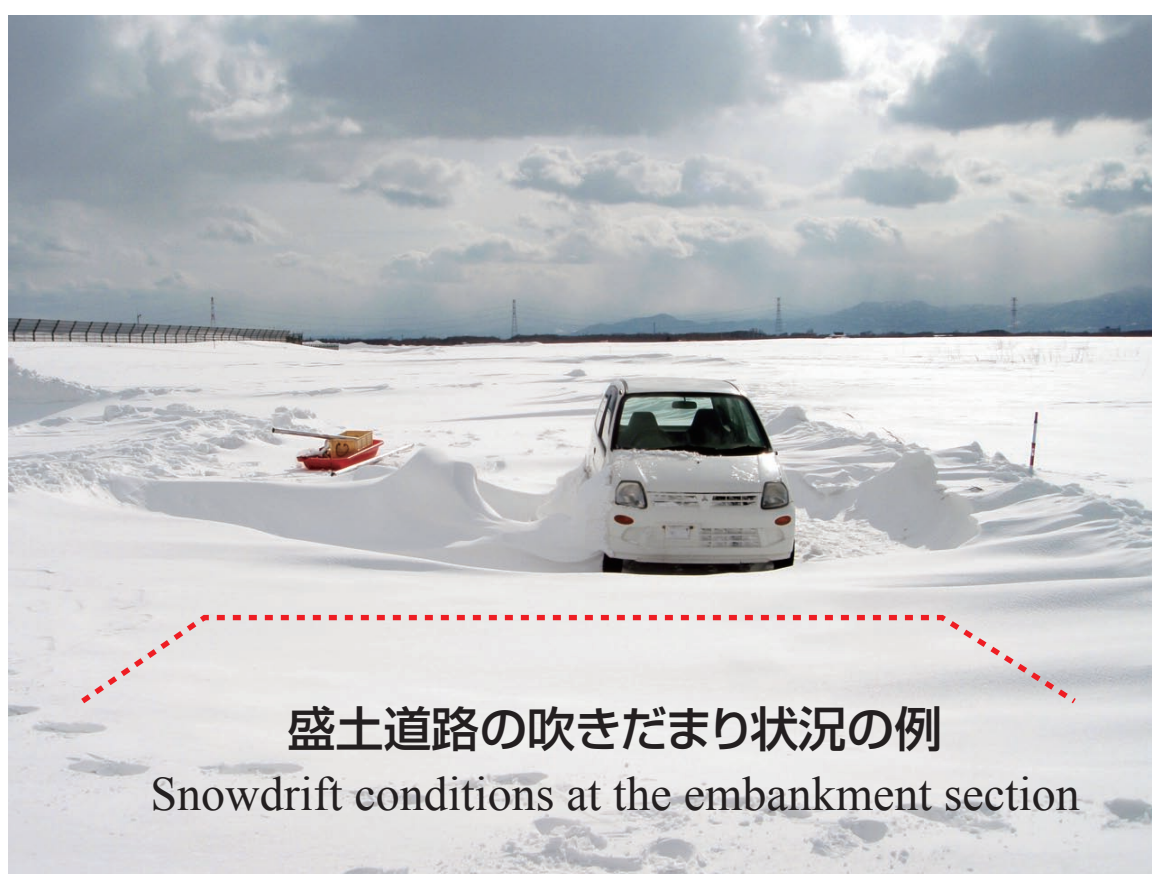
盛土道路の吹きだまり状況の例  
Snowdrift conditions at the embankment section

盛土道路や切土道路で、どのように吹きだまりが発達するのかについて把握するため、実験場内の道路にて吹きだまりの現地観測を実施しました。観測の結果、盛土道路では目立った吹きだまりは見られませんが、切土道路では顕著な吹きだまりの発生が見られました。

To understand the development of snowdrifts on embankments and cuts of roads, we conducted an observation survey on roads at our experiment field. The observations showed that no noticeable snowdrift formed at the embankment section, but snowdrifts formed remarkably at the cut section.

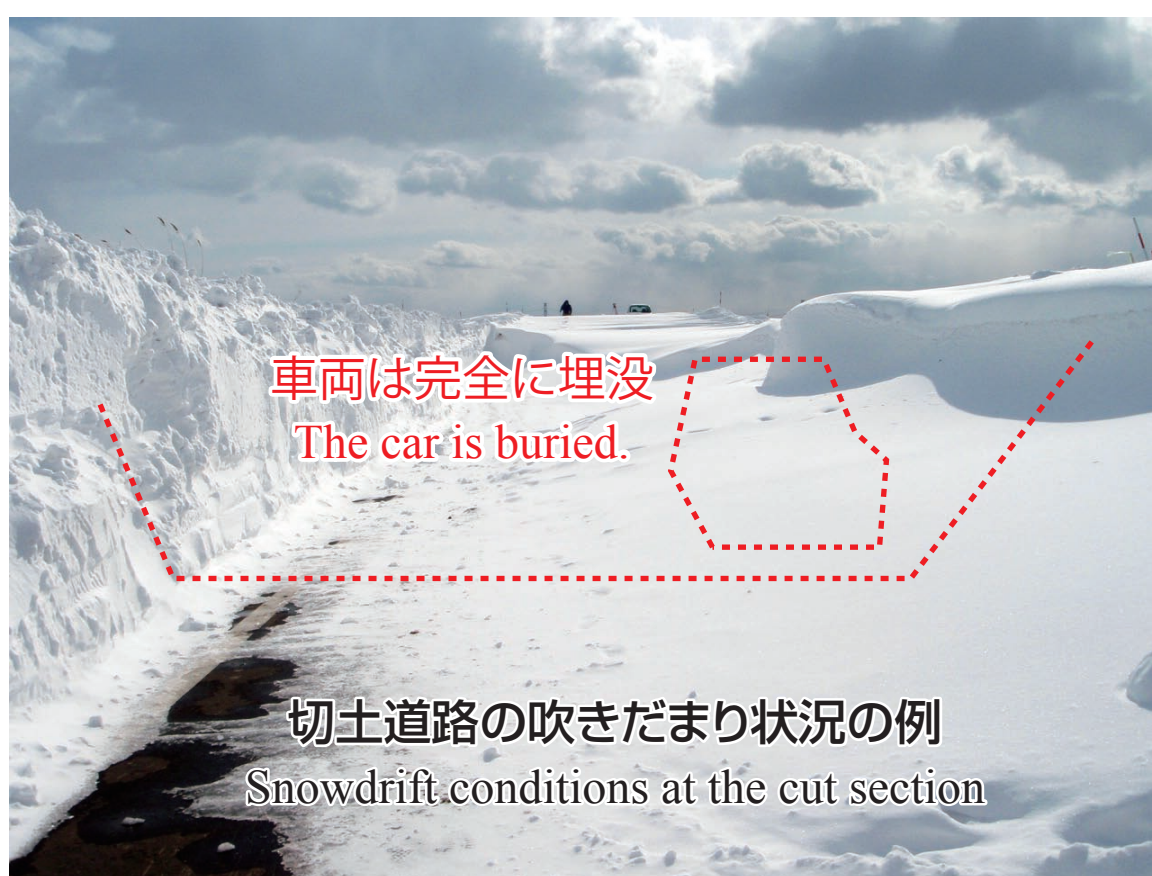
車両は完全に埋没  
The car is buried.

切土道路の吹きだまり状況の例  
Snowdrift conditions at the cut section

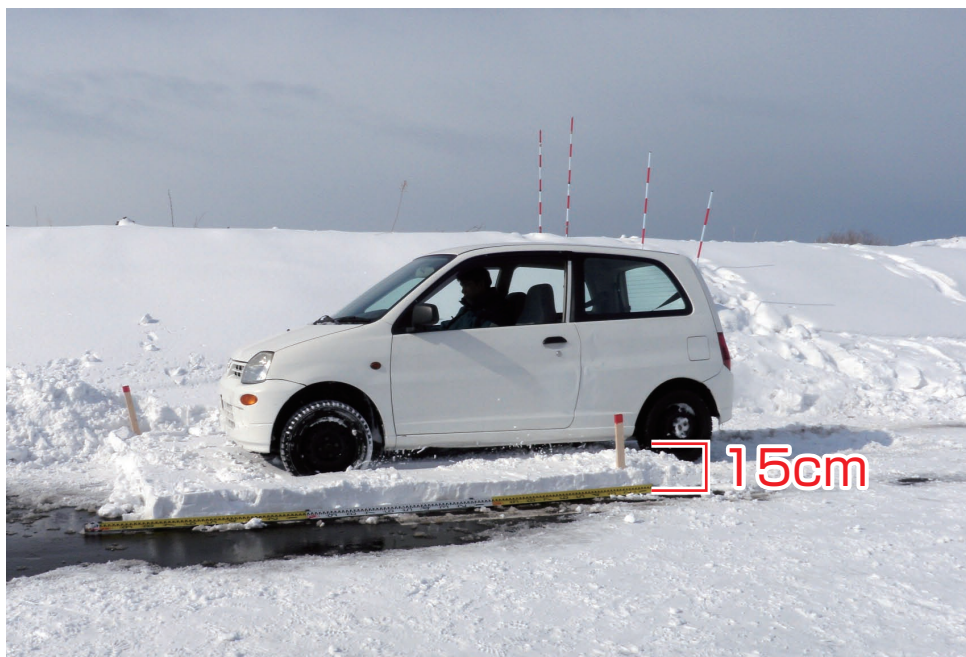
▲吹きだまり深さ 15cm：発進可能

15cm-deep snowdrift:

Starting from a standstill is possible

道路上にどの程度の深さの吹きだまりができた場合に、自動車の走行が困難となるのかについて把握するため、実際の吹きだまりを切り取り整形し、車両の発進実験を実施しました。その結果、深い吹きだまり(20cm)では、発進が困難となることが判りました。

To determine the snowdrift depth at which cars become snowbound, we conducted a car departure test in snowdrifts whose depth we adjusted by making cuts. The experiment revealed that the car became incapable of starting from a standstill at snowdrift depths of about 20cm.

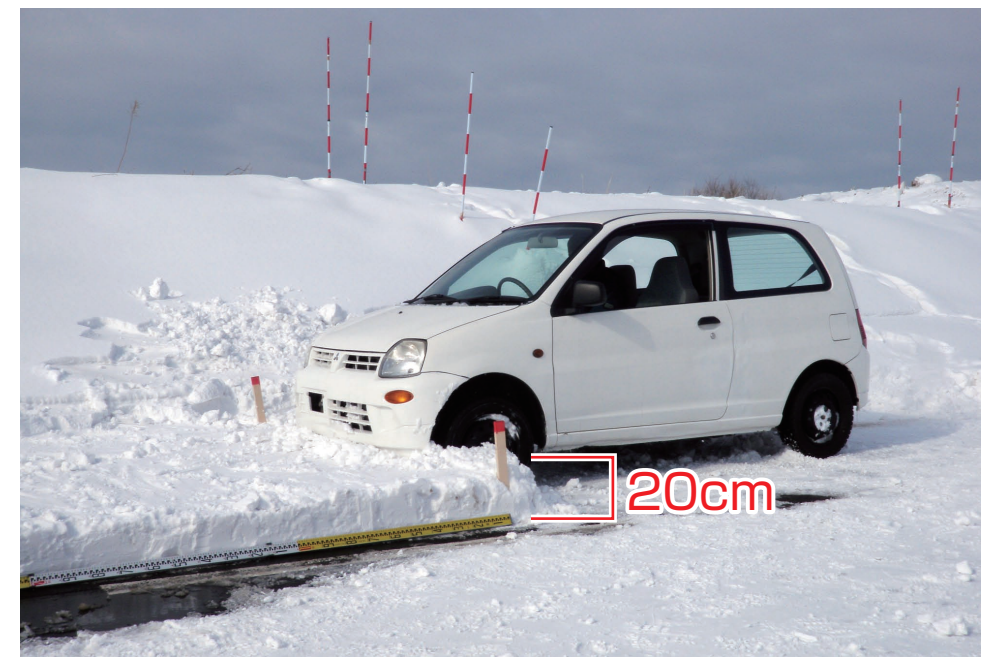
▲吹きだまり深さ 20cm：発進不能

20cm-deep snowdrift:

Starting from a standstill is impossible
