路線を通した連続的な吹雪の危険度評価技術に関する研究

Study Related to Snowstorm Risk Assessment Technologies That Target Entire Routes

寒地土木研究所では、吹雪障害への危険要因やその影響度を定量的に解明することで、路線全体を通しての連続的な吹雪危険度評価技術の開発に取り組んでいます。

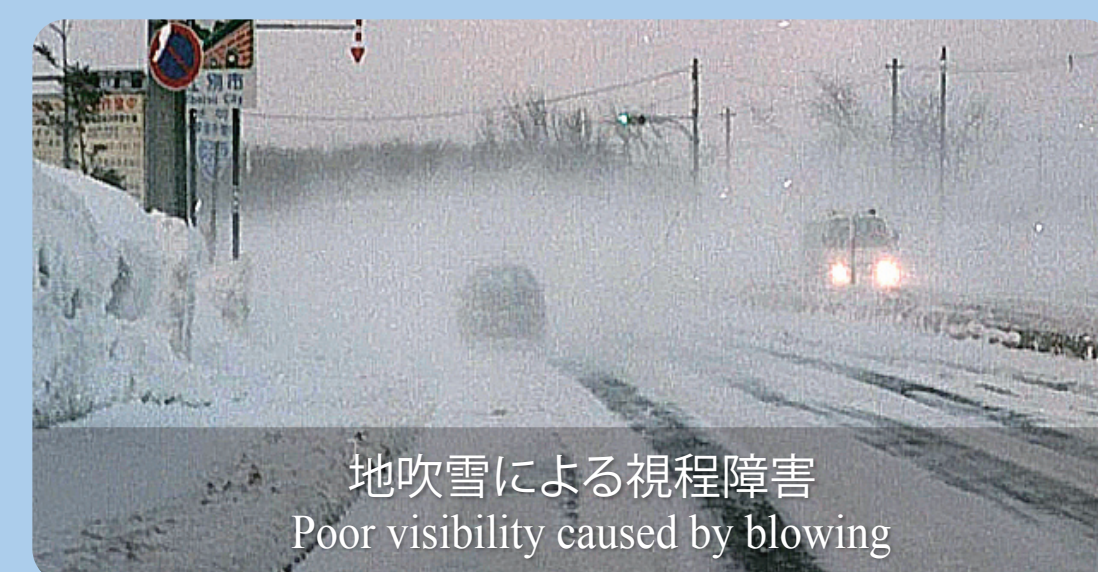
地吹雪による視程障害
Poor visibility caused by blowing

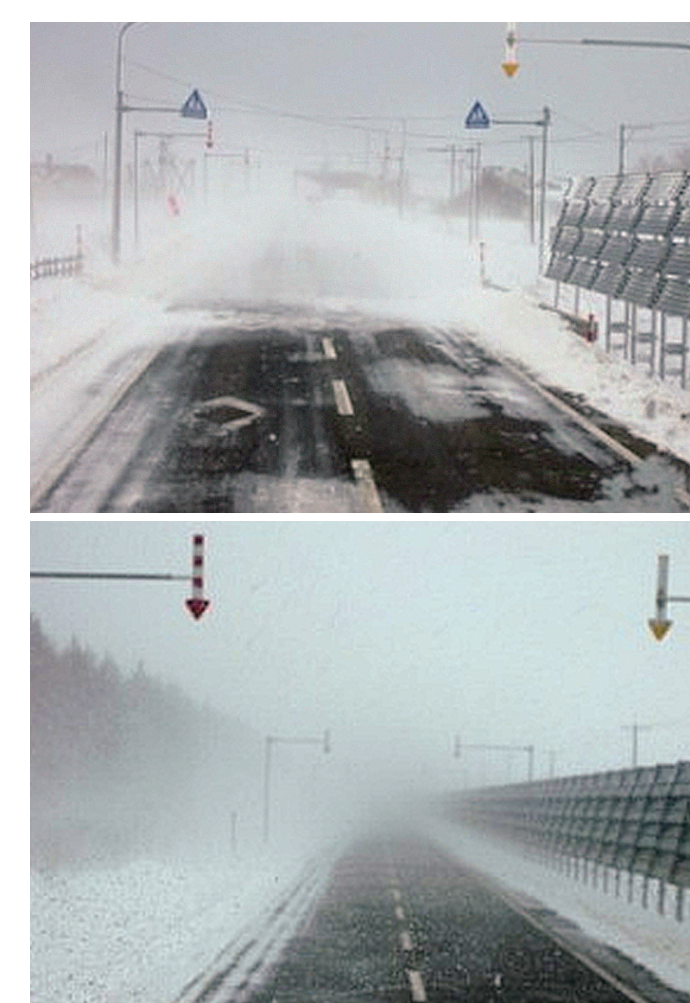
▲吹雪災害対策の効率的な整備
Effective installation of snowstorm countermeasures

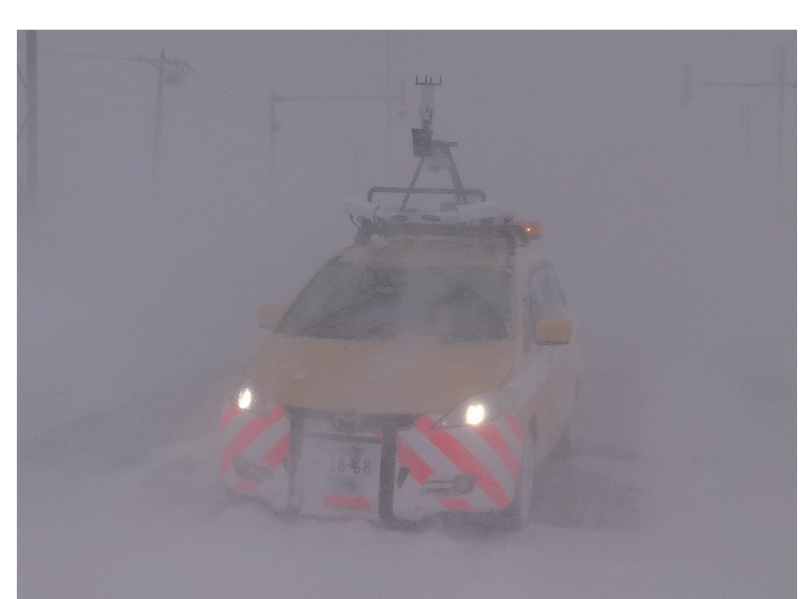
▲視程障害移動観測車による観測状況
The visibility observation vehicle making observations

視程障害移動観測車を用い、吹雪時の視程、風向風速、気温、走行速度やブレーキ踏力、アクセル踏量、ハンドル操舵角を計測しました。また、助手席の調査員により運転危険度を表に示す5ランクで記録しました。その結果、防雪柵の端部や開口部では、視程が50m未満に大きく低下し、ブレーキ操作による速度低下やハンドル操作のふらつきが発生するなど、運転の危険性が高くなることが分かりました。

The visibility distance during blowing snow and the wind direction and velocity, temperature, traveling speed, force applied on the brake pedal, accelerator position, and the steering wheel angle were measured by using a visibility observation vehicle. A researcher in the front passenger seat recorded the level of driving risk in the five ranks shown in the table below. The survey using the vehicle found that the driving risk tends to increase at the ends and openings of snow fences. The visibility distance decreased to less than 50 m, the travel speed was reduced because of brake application, and unsteady handling of the steering wheel occurred at such sites.

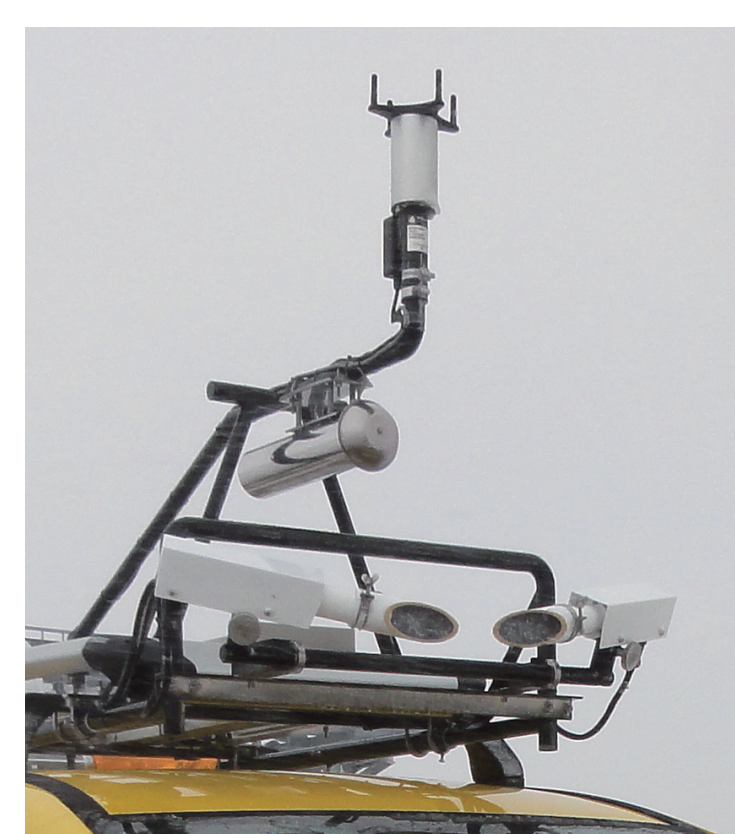
▲視程観測装置
Visibility observation equipment
