切土道路における吹きだまり予測モデル開発に関する研究

Study on the Development of a Model for Forecasting Snowdrift at a Cut Road Section

吹きだまり予測モデル開発に向けた研究概要

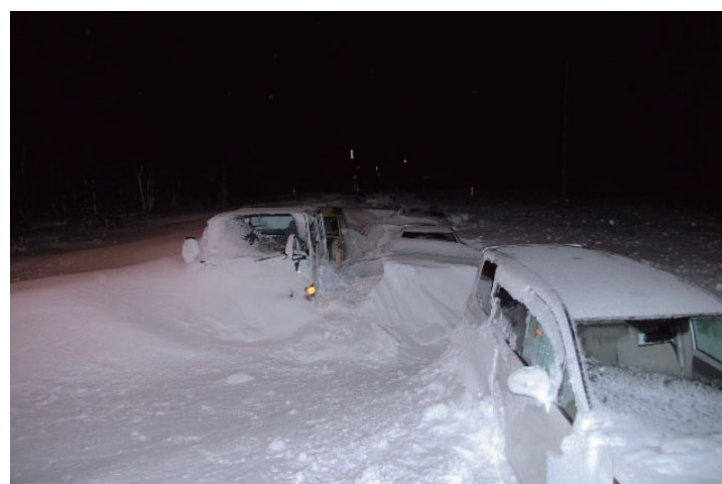
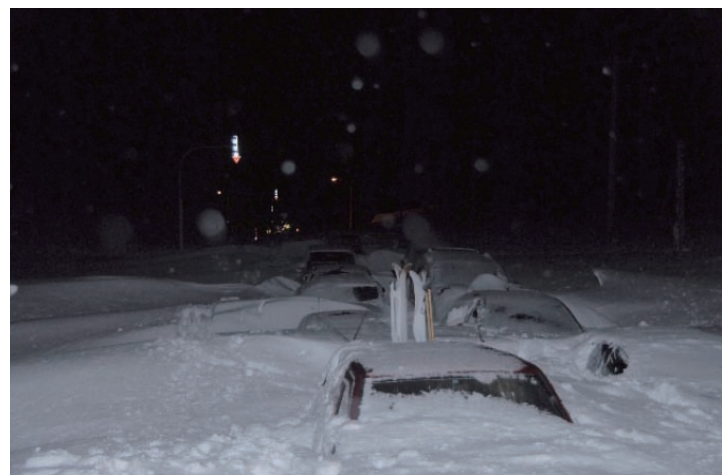
国道 336 号えりも町 (H22.1.5-6)
(室蘭開発建設部提供)
National Highway 336 in Erimo Town
(January 5 - 6, 2010)
Source: Muroran Development and Construction Department

吹きだまりによる車両の立ち往生
Vehicles trapped in snowdrifts

例えば、2013年3月2日から3日には、北海道全域で大荒れの天候となり、道東地方を中心に9名の死者を出す惨事となりました。また、2010年1月にはえりも町内の切土道路で車両50台が吹きだまりにより立ち往生する等、吹きだまり災害の防止が喫緊の課題となっております。

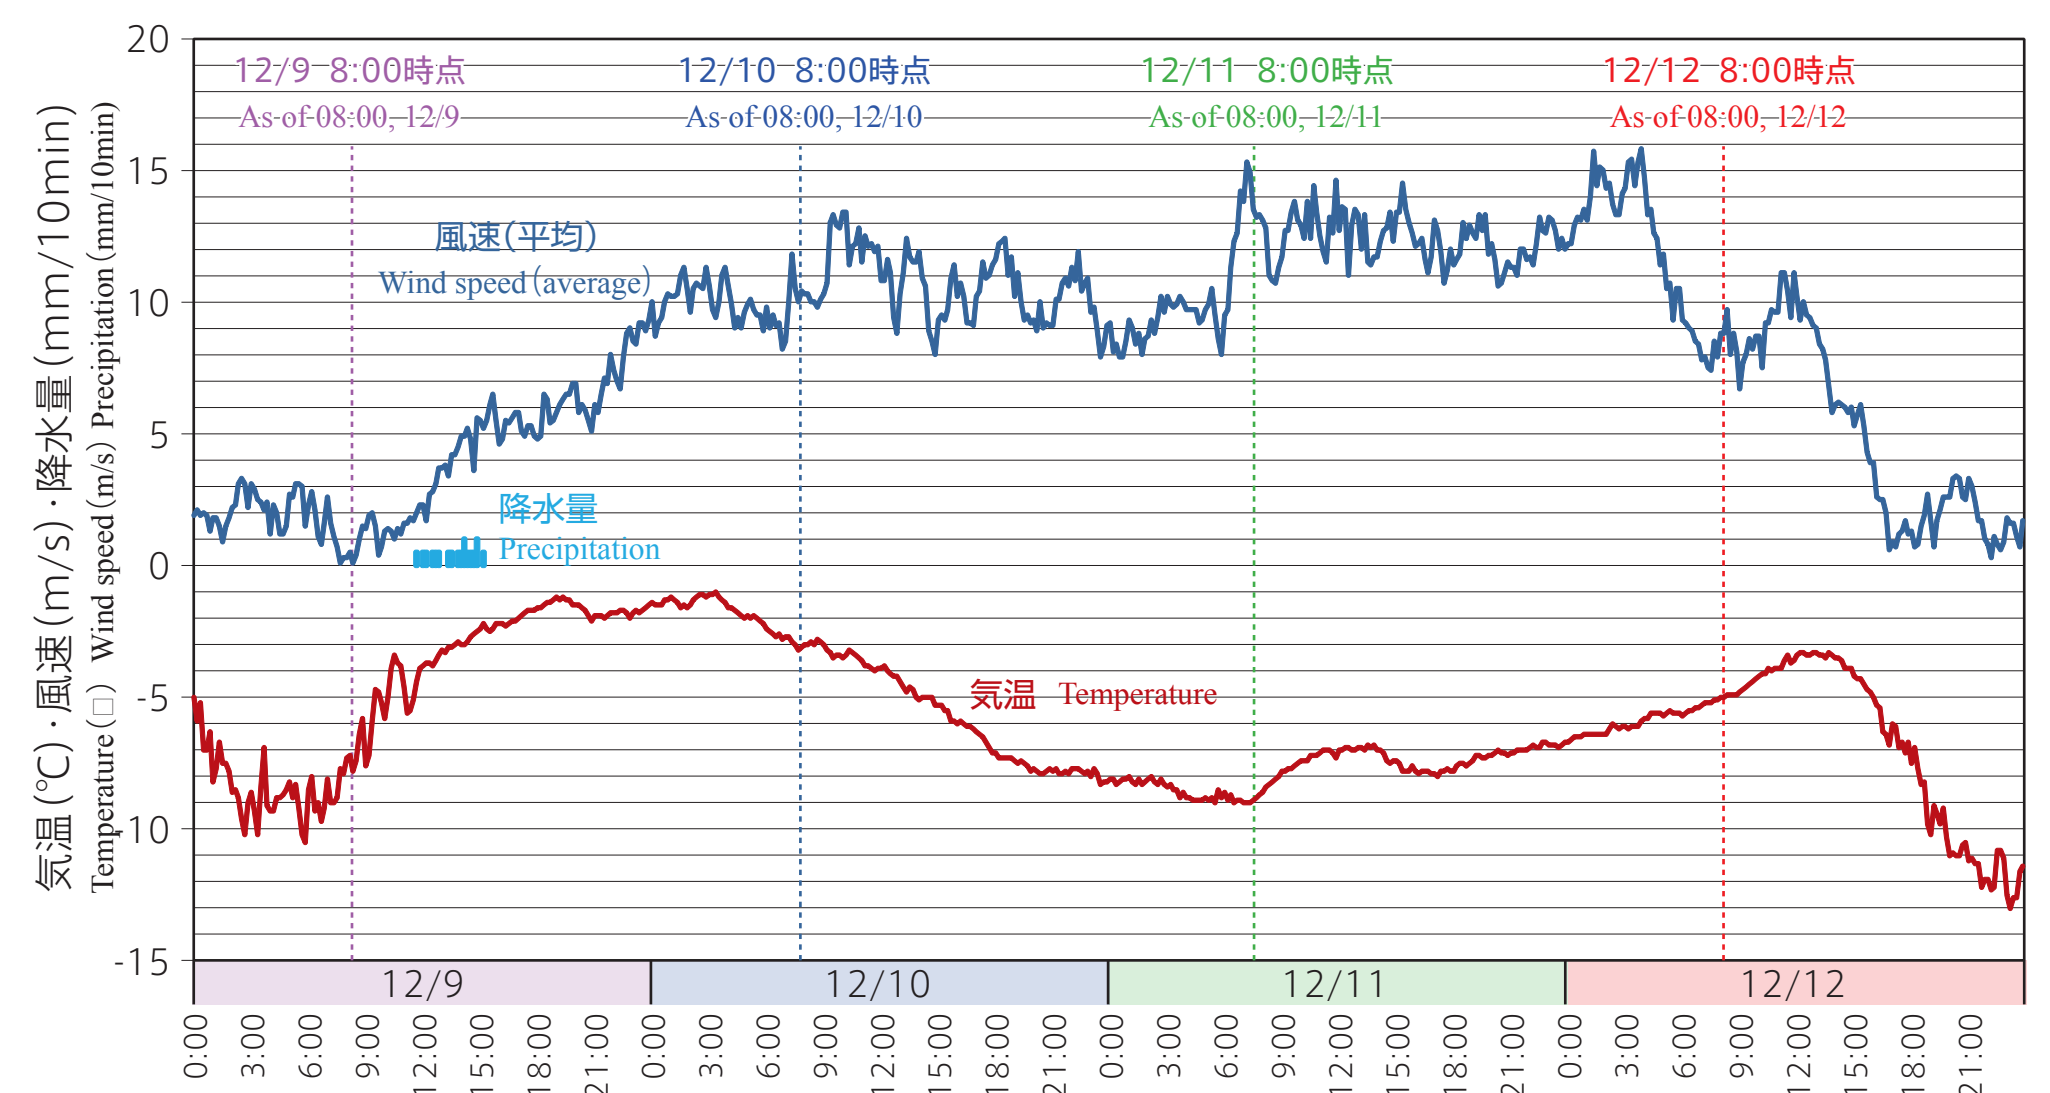
▲観測時の気象条件(弟子屈アメダス)
Weather conditions at observation (Amedas: Teshikaga)

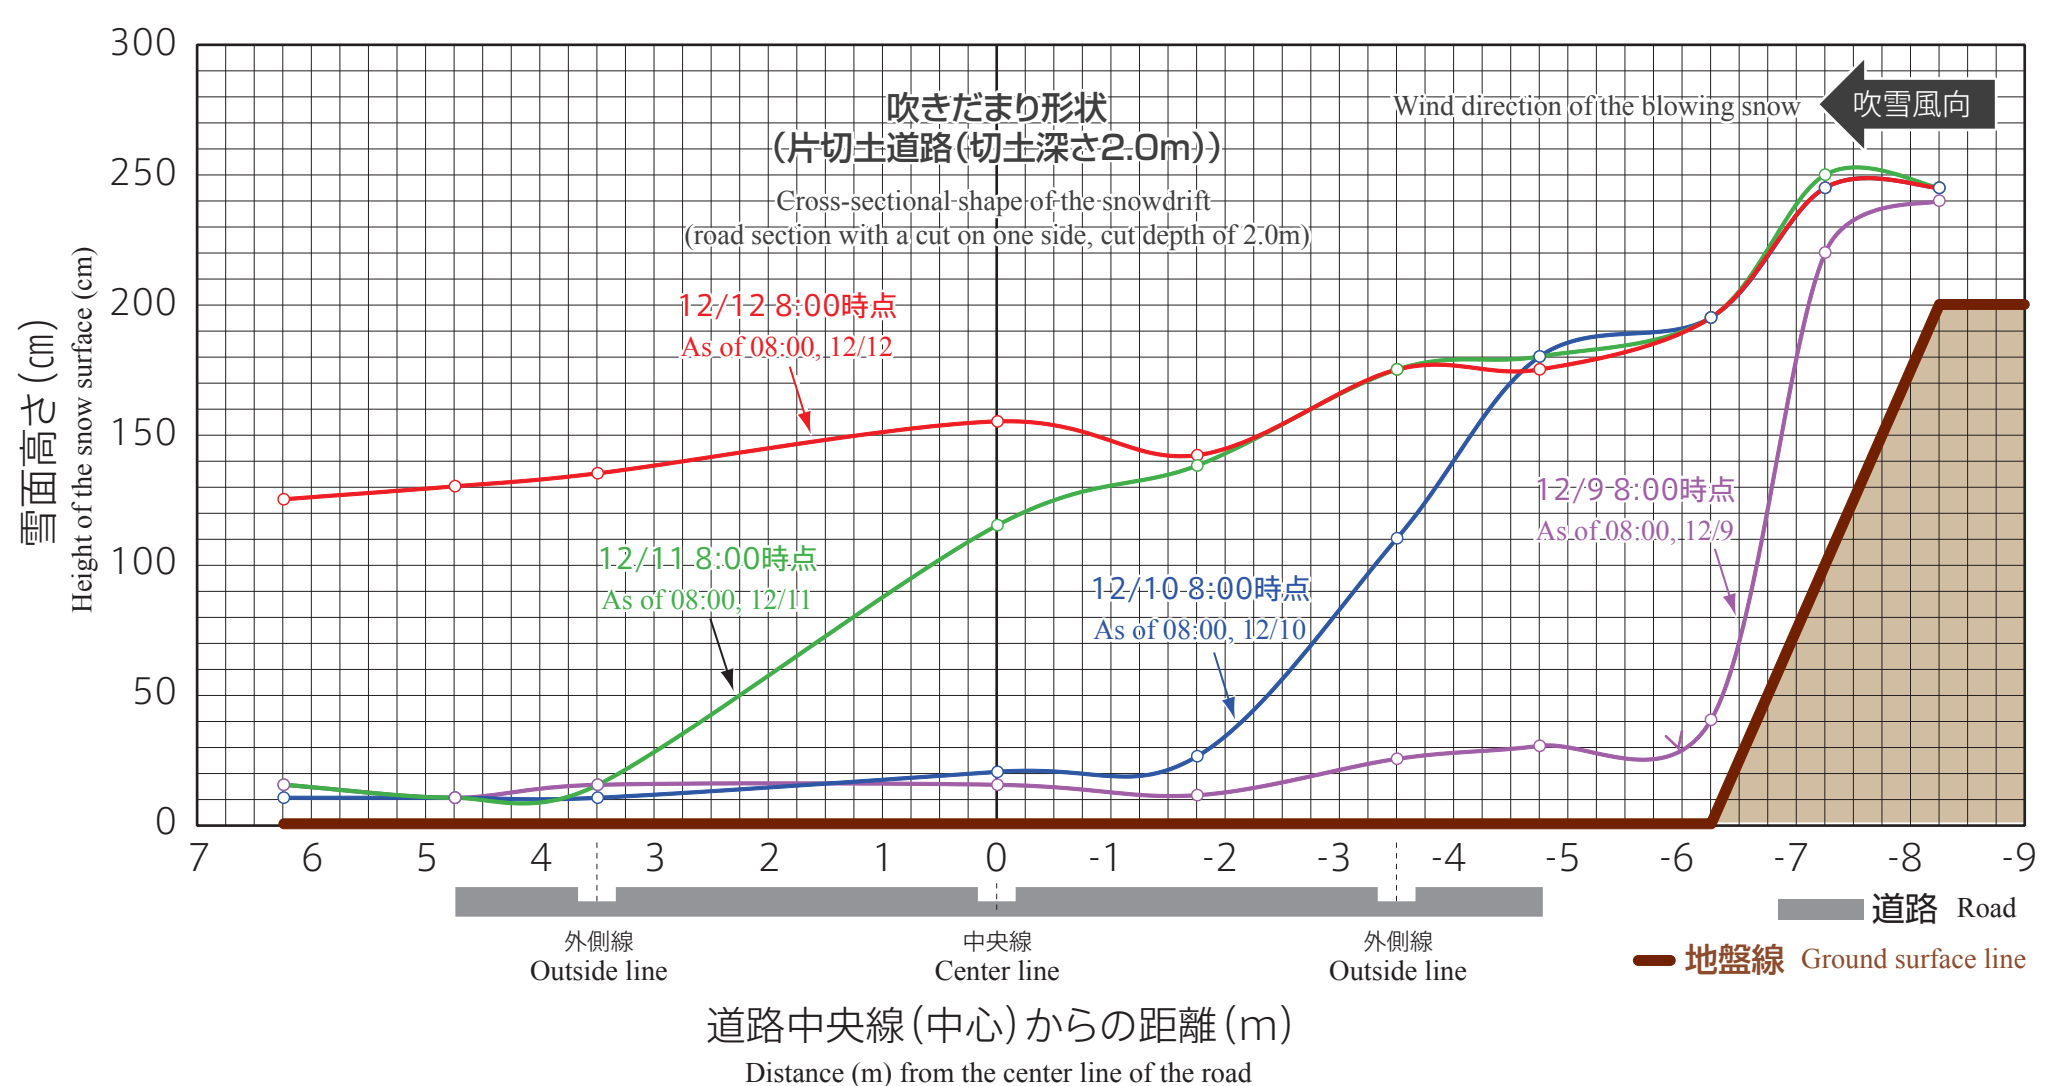
▲片切土における吹きだまり形状の変化 (2016/12/9-12/12)
Change in the shape of a snowdrift on a cut section of a road (2016/12/9-12/12)

その結果、吹きだまりは風上側の切土法面上から風下側に想定した道路に向かって発達し、風上側の車線中心に相当する位置においては深さ113cmの吹きだまりが概ね13時間で急激に発達することなどを明らかにしました。
